Watch Timing Marks on Flywheel when Replacing

How to Punch Mark Timing Gears

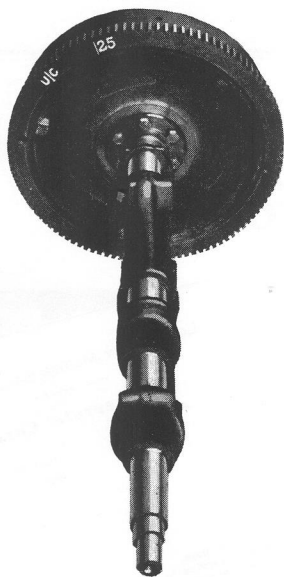
Figure 1

The flywheel to crankshaft bolt holes are evenly spaced, 60° apart and it is, therefore, possible to assemble six different positions.

If not correctly assembled, it will be impossible to time motor from flywheel markings. Instances of this have been noted and reported to us.

We are illustrating in Fig. 1 the correct relation between flywheel markings and crankshaft, and if mechanics will get this firmly fixed in mind, it will be easy to remember.

**No. 1 and No. 4
crank
throws are
up in this
illustration**

Two views of a correctly assembled flywheel and crankshaft are shown in Figs. 1 and 2. In both of these the crankshaft is in the position with No. 1 and No. 4 throws up. If assembled in the motor, No. 1 and No. 4 pistons would be at top dead center.

With crankshaft as stated, the flywheel should be assembled so that the marking "25" is to left of No. 4 crank throw as shown. This is left, looking at flywheel from front of motor. If assembled one hole in either direction, the "25" marking will be moved 60° one way or the other and can be quickly noted as wrong.

Remember it in this way. Your ignition timing according to instructions is always done with No. 1 piston on the up compression stroke. Therefore, the "25" flywheel timing mark must be just to left of No. 1 crank.

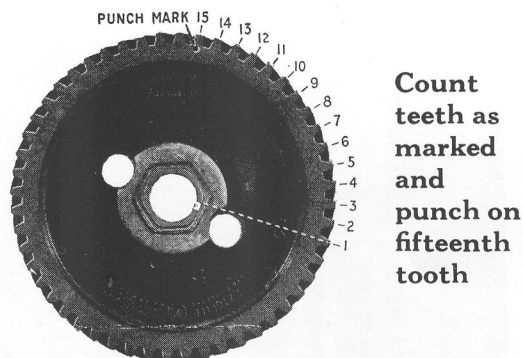
Figure 4

The statement on Page 43 of the Series AB Repair Manual is correct. The illustration on Page 42 of Series AB Gears, however, does not tie in with the instructions.

In Fig. 4 is shown the camshaft gear. This marking is located by starting to count with the tooth exactly opposite the keyway as indicated. Calling this tooth No. 1, count anti-clockwise, or to the left, 15 teeth and punch mark the fifteenth tooth.

These statements apply to all gears whether fabric or steel.

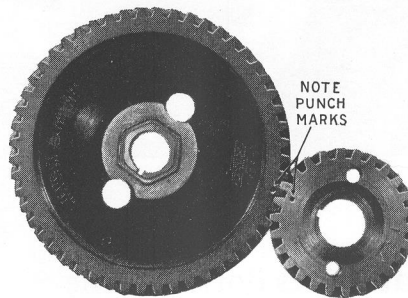
Figure 5

When mated properly, the tooth which is marked on camshaft gear should be matched with the mark on crankshaft gear as illustrated in Fig. 5.
